Subject: TCS / DSC WARNING LIGHT ON WITH DTC C1956	Bulletin No: 09-004/08
	Last Issued: 01/22/2008

2006-2007 Mazdaspeed6 vehicles with VINs lower than JM1GG****7*110516 (produced before June 6, 2007)

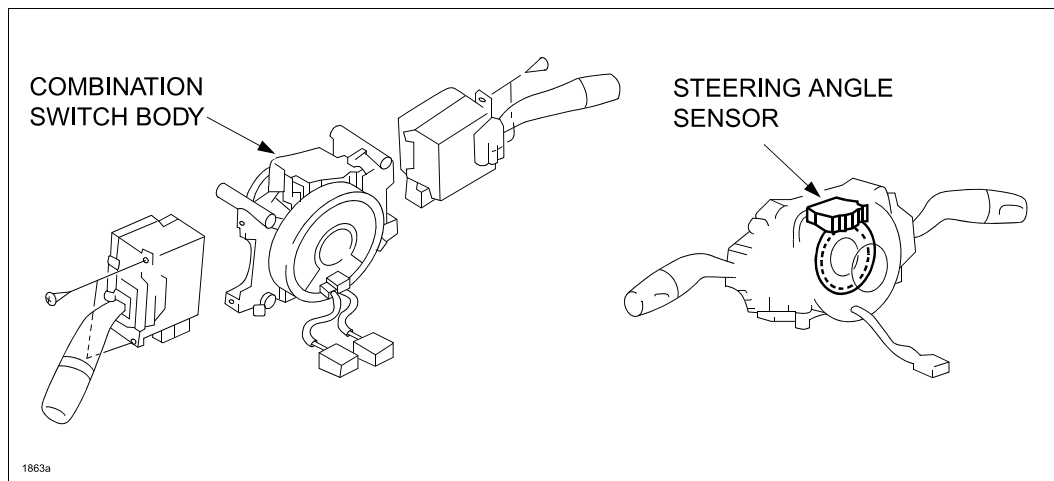
Depending on the size variation in the production of related combination switch parts on the steering shaft, steering angle sensor parts may come in contact with each other causing debris to attach to the steering angle sensor. The debris can cause abnormal signals resulting in a TCS/DSC warning light illumination.

1. Verify customer concern.
2. Record customer's preset radio stations, then disconnect negative battery cable.
3. Replace combination switch body with a modified part according to Workshop Manual (section 09-18 COMBINATION SWITCH REMOVAL/INSTALLATION).
